**DEPARTMENT OF TRANSPORTATION****DIVISION OF ENGINEERING SERVICES**

Contract #: 04-0120F4Cty: SF/ALA Rte: 80 PM: 13.2/13.9File #: 13.28**WELDING INSPECTION REPORT****Resident Engineer:**Pursell, Gary**Address:** 333 Burma Road**City:** Oakland, CA 94607**Report No:** WIR-007676**Date Inspected:** 13-Jul-2009**Project Name:** SAS Superstructure**OSM Arrival Time:** 700**Prime Contractor:** American Bridge/Fluor Enterprises, a JV**OSM Departure Time:** 1530**Contractor:** Oregon Iron Works Clackamas, Or.**Location:** Clackamas, OR**CWI Name:** Mike Gregson, Jose Salazar**CWI Present:** Yes No**Inspected CWI report:** Yes No N/A**Rod Oven in Use:** Yes No N/A**Electrode to specification:** Yes No N/A**Weld Procedures Followed:** Yes No N/A**Qualified Welders:** Yes No N/A**Verified Joint Fit-up:** Yes No N/A**Approved Drawings:** Yes No N/A**Approved WPS:** Yes No N/A**Delayed / Cancelled:** Yes No N/A**Bridge No:** 34-0006**Component:** Hinge K Pipe Beams**Summary of Items Observed:**

**OIW Fabrication Shop-Bay 3****Hinge-K Pipe Beam Assembly 102A-1: 7/13/09**

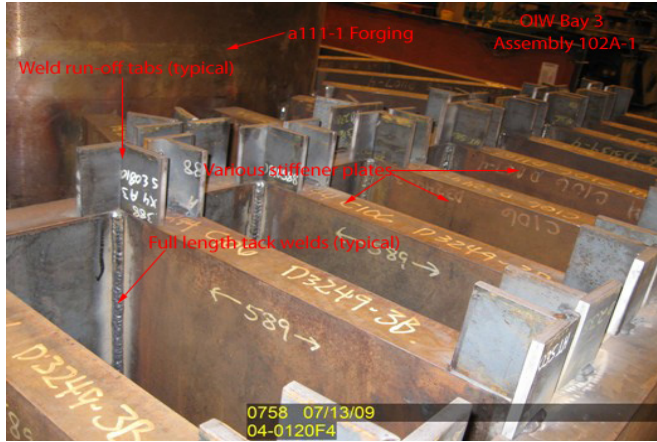
QA Inspector noticed that all stiffener plates were tack welded and this assembly 102A-1 was sitting idle, pending transfer to the welding positioner for submerged arc welding on these PJP and fillet welds. See attached picture below.

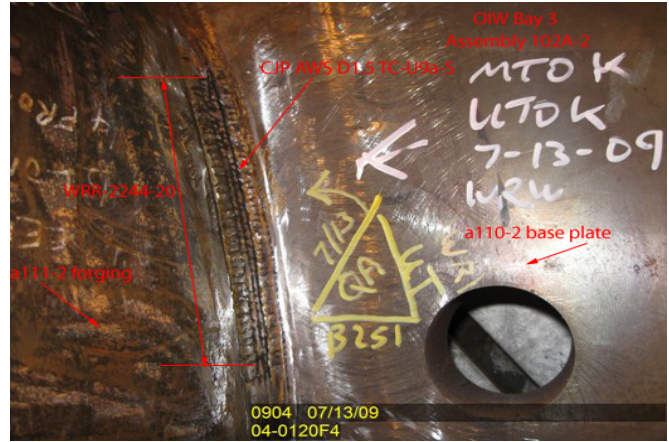
**Hinge-K Pipe Beam Assembly 102A-2: 7/13/09**

QA Inspector spoke with lead QC Inspector Mike Gregson and Mr. Gregson explained that the weld repair (WRR 2244-20), a111-2 forging to a110-2 base plate, designated as weld joint #W2-12/W2-13, had been previously completed on 7/9/09 and 100% ultrasonic weld inspection had been performed by QC Inspector Rob Walters on 7/13/09, after the required 72hrs. cooling time period, per AWS D1.5. QA Inspector spoke with QC Inspector Rob Walters and Mr. Walters explained that the ultrasonic weld inspection was performed utilizing a 60 and 70 degree

transducer angle from face "A" (exterior) and a 60 degree transducer angle from face "B" (interior). Mr. Walters also explained that no rejectable/recordable indications were found and the applicable ultrasonic weld testing report was in-process of being completed and QA Inspector would be provided with a copy of the completed report. QA Inspector performed 100% ultrasonic weld inspection on this weld repair (WRR 2244-20), a111-2 forging to a110 base plate, designated as weld joint #W2-12/W2-13, utilizing a 60 and 70 degree transducer angle from face "A" (exterior) and a 60 degree transducer angle from face "B" (interior) and found no rejectable/recordable indications. QA Inspector notified lead QC Inspector Mike Gregson of the ultrasonic testing results and completed the applicable ultrasonic testing report (TL6027), on this date. See attached picture below.
